2008 HUMMER H2 | H2 (VIN N) Service Manual | Driver Information and Entertainment |
Cellular, Entertainment, and Navigation | Repair Instructions | Document ID: 1937691

Communication Interface Module Replacement

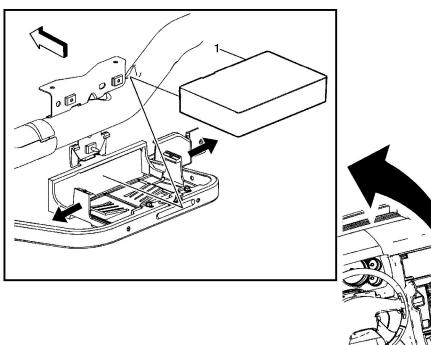
1

Communication Interface with Mobile Telephone Transceiver Module

- 1. Push outward on the two tabs to release the communication interface module from the bracket.
- 2. Disconnect the electrical connectors.
- 3. Reprogram the communication interface module after replacement. Refer to Control Module References.
- 4. When replacing the communication interface module be sure to transfer Bluetooth Antenna, if equipped.
