2009 Buick Allure | Allure, LaCrosse (VIN W) Service Manual | Driver Information and Entertainment | Cellular, Entertainment, and Navigation | Repair Instructions | Document ID: 2103767

Communication Interface Module Replacement

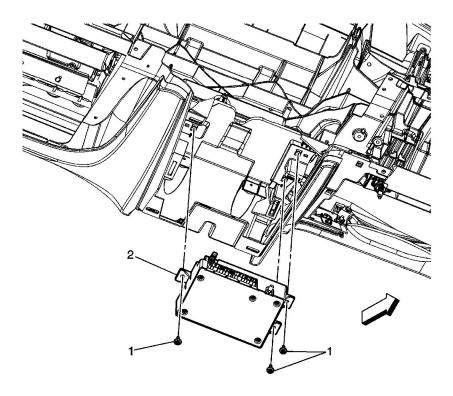
Callout	Component Name
Preliminary Procedure	
Remove the Front Floor Console. Refer to Front Floor Console Replacement	
	Communication Interface Module Bolt (Qty: 3)
1	Caution: Refer to <u>Fastener Caution</u> in the Preface section.
	Tighten 10 N·m (89 lb in)
	Communication Interface Module
	Procedure
2	 Disconnect the electrical connections. If Replacing the Communication Interface Module be sure to transfer Bluetooth Antenna, if equipped. Refer to Control Module References for programming and set up procedures.
