Communication Interface Module Replacement

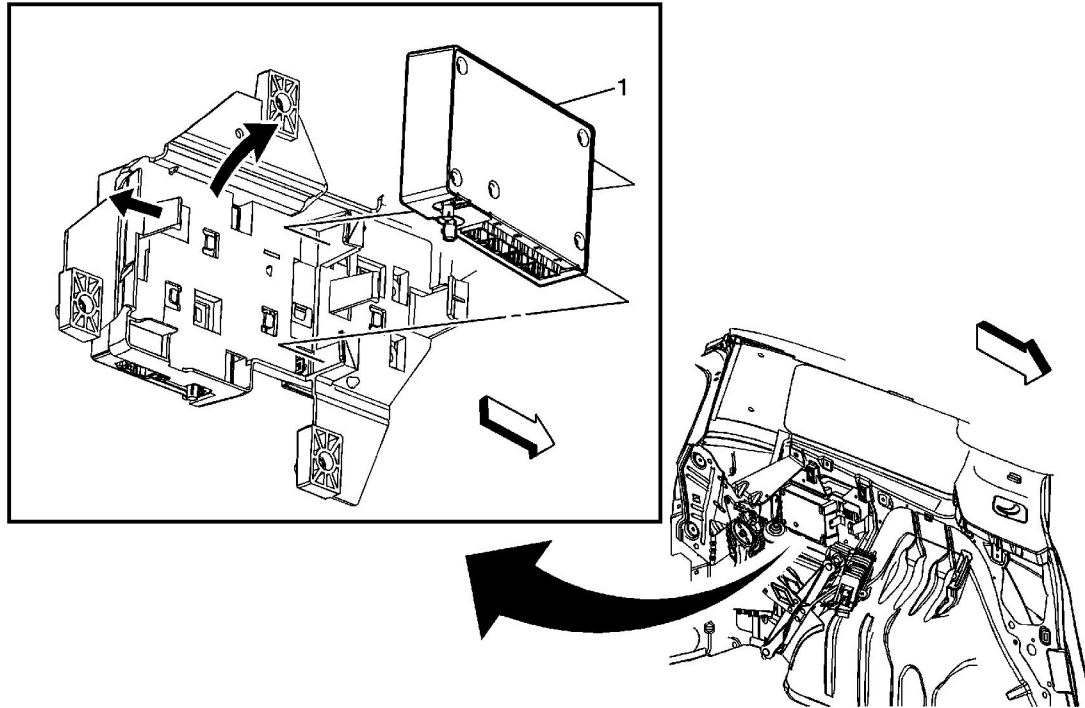
Callout	Component Name
<p>Preliminary Procedure</p> <p>Remove the left rear quarter lower trim panel. Refer to Quarter Lower Rear Trim Panel Replacement.</p>	
<p>1</p>	<p>Communication Interface Module</p> <p>Procedure</p> <ol style="list-style-type: none"> 1. Disconnect the electrical connectors. 2. When replacing the communication interface module be sure to transfer Bluetooth Antenna, if equipped. 3. Reprogram the communication interface module if replaced. Refer to Control Module References. 4. When replacing the VCIM, record the 11-digit electronic serial number (ESN) and the 10-digit station identification (STID) number from the label on the new VCIM. <p>Tip</p> <ul style="list-style-type: none"> • The vehicle communication interface module (VCIM) has a specific set of unique numbers that tie the module to each vehicle. These numbers, the 10- <p>© 2012 General Motors Corporation. All rights reserved.</p>
