2009 Buick LaCrosse | Allure, LaCrosse (VIN W) Service Manual | Driver Information and Entertainment |
Cellular, Entertainment, and Navigation | Repair Instructions | Document ID: 2103767

## **Communication Interface Module Replacement**

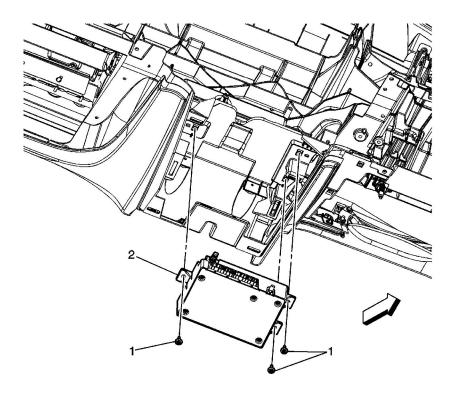
Callout	Component Name
Preliminary Procedure	
Remove the Front Floor Console. Refer to Front Floor Console Replacement	
	Communication Interface Module Bolt (Qty: 3)
1	Caution: Refer to Fastener Caution in the Preface section.
	Tighten 10 N·m (89 lb in)
	Communication Interface Module
	Procedure
2	<ol> <li>Disconnect the electrical connections.</li> <li>If Replacing the Communication Interface Module be sure to transfer Bluetooth Antenna, if equipped.</li> <li>Refer to Control Module References for programming and set up procedures.</li> </ol>
