Communication Interface Module Replacement

Removal Procedure

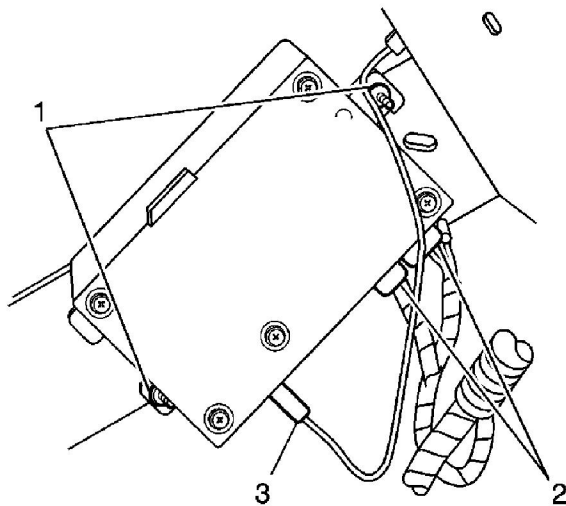
2. Disconnect the antenna (3) and electrical connections (2) from the vehicle communication interface module (VCIM).
3. Remove the bolts (1) securing the VCIM.
4. Remove the vehicle VCIM from the vehicle.
