Communication Interface Module Replacement

Removal Procedure

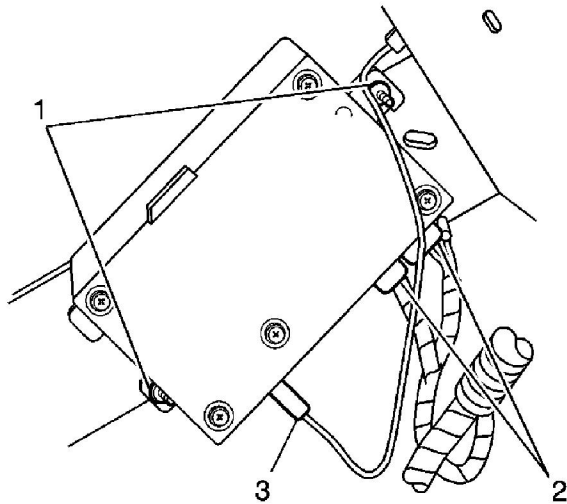
1. When replacing the VCIM, record the 11-digit electronic serial number (ESN) and the 10-digit station identification (STID) number from the label on the new VCIM (4).
2. When replacing the VCIM, be sure to transfer Bluetooth Antenna, if equipped.
3. Position the VCIM in the vehicle.

4. Install the bolts (1).

Tighten the bolts (1) to 4 N·m (36 lb in).

5. Connect the antenna cable (2) and electrical connections (3) to the VCIM (4).
6. Install the rear compartment trim. Refer to [Rear Compartment Trim Panel Replacement](#).
