2006 Buick Rainier | Envoy, Rainier, TrailBlazer, Ascender (VIN S/T) Service Manual | Accessories |

Communication Interface Module Replacement (Trailblazer, Envoy, Rainier)

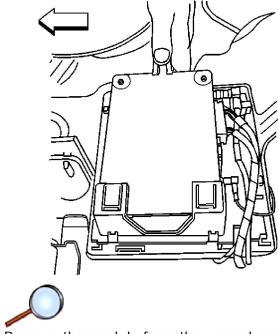
3. Remove the module from the upper bracket by releasing the retaining tab.
