# Communication Interface Module Replacement

## Removal Procedure

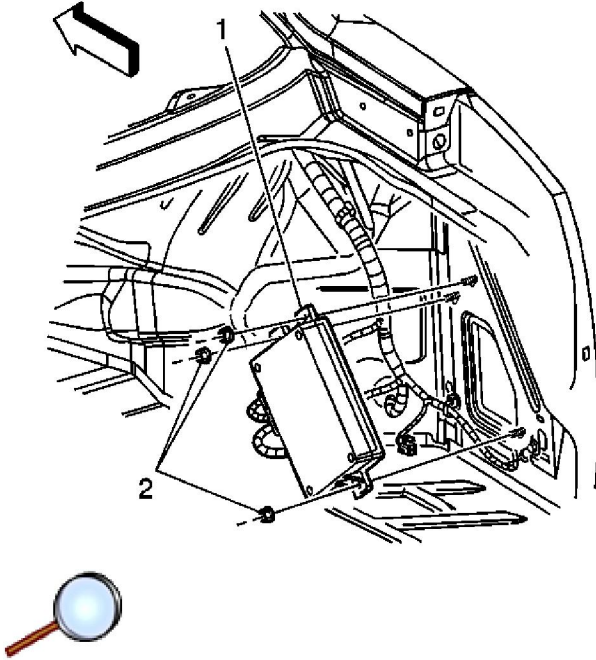
**Important:** The vehicle communication interface module (VCIM) has a specific set of unique numbers that tie the module to each vehicle. These numbers, the 10-digit station identification and the 11-digit electronic serial number, are used by the National Cellular Network and OnStar® to identify the specific vehicle. Because these numbers are tied to the vehicle identification number of the vehicle, you must never exchange these parts with those of another vehicle.

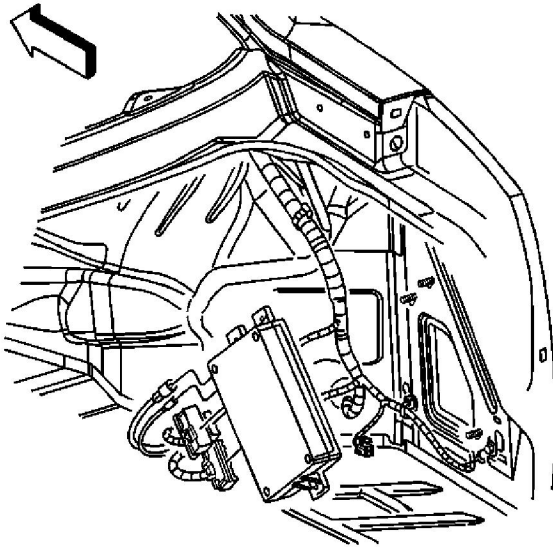
1. Remove the right rear compartment trim. Refer to [Rear Compartment Trim Panel Replacement](#) in Body Rear End.
2. Remove the nuts (2) securing the OnStar® module (1) to the vehicle body.

3. Disconnect all the electrical connectors from the module.
4. Remove the module from the vehicle.

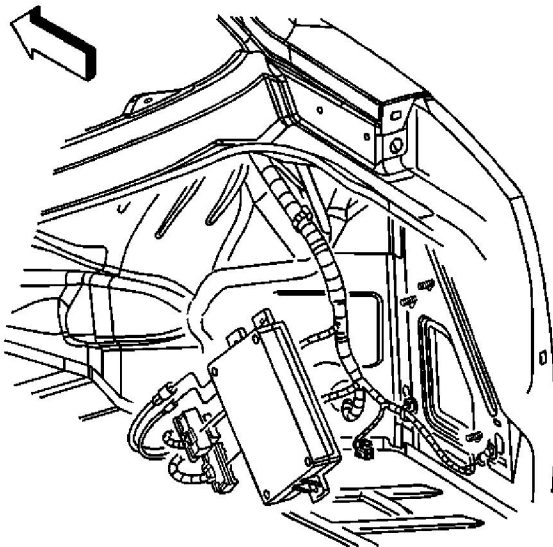
1. When replacing the VCIM, record the 11-digit electronic serial number (ESN) and the 10-digit station identification (STID) number from the label on the new VCIM.
2. Reconnect the electrical connectors the module.

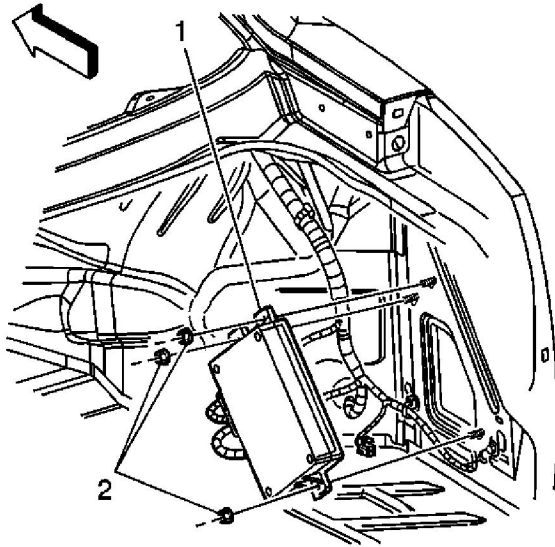
3. Install the module onto the vehicle.

Tighten the nuts to 9 N·m (80 lb in).
