Communication Interface Module Replacement

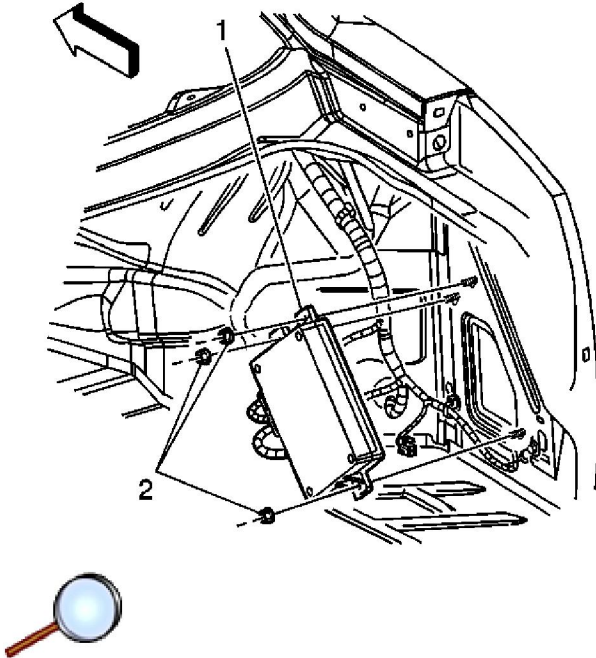
Important: The vehicle communication interface module (VCIM) has a specific set of unique numbers that tie the module to each vehicle. These numbers, the 10-digit station identification and the 11-digit electronic serial number, are used by the National Cellular Network and OnStar® to identify the specific vehicle. Because these numbers are tied to the vehicle identification number of the vehicle, you must never exchange these parts with those of another vehicle.

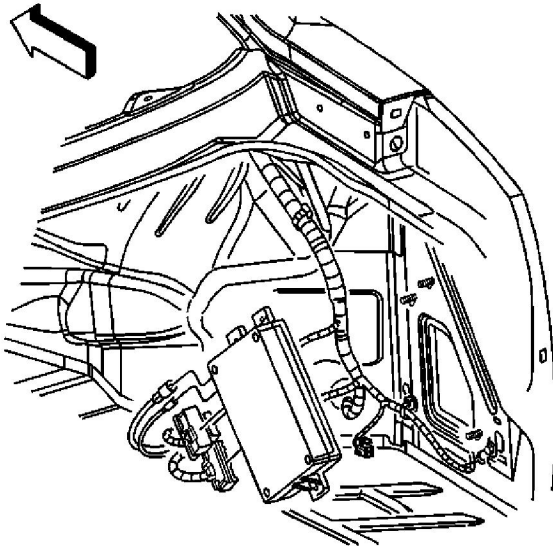
1. When replacing the VCIM, record the 11-digit electronic serial number (ESN) and the 10-digit station identification (STID) number from the label on the new VCIM.
2. Reconnect the electrical connectors the module.
