Communication Interface Module Replacement

Removal Procedure

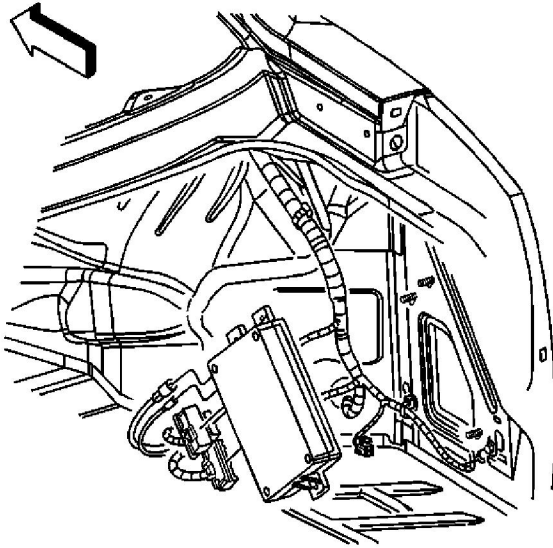
1. When replacing the VCIM, record the 11-digit electronic serial number (ESN) and the 10-digit station identification (STID) number from the label on the new VCIM.
2. Reconnect the electrical connectors the module.
