Communication Interface Module Replacement

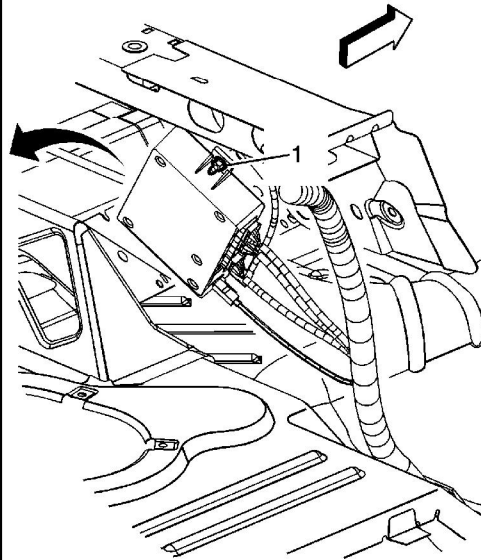
Callout	Component Name
<p>Important: The vehicle communication interface module (VICM) has a specific set of unique numbers that tie the module to each vehicle. These numbers, the 10-digit station identification and the 11-digit electronic serial number, are used by the National Cellular Network and OnStar® to identify the specific vehicle. Because these numbers are tied to the vehicle identification number of the vehicle, you must never exchange these parts with those of another vehicle.</p>	
<p>Important: After replacing the vehicle communication interface module, you must reconfigure the OnStar® system. Failure to reconfigure the system will result in an additional customer visit for repair. In addition, pressing and holding the white dot button on the keypad will NOT reset this version of the OnStar® system. This action will cause a DTC to set.</p>	
<p>Important: When replacing the Communication Interface Module be sure to transfer Bluetooth Antenna, if equipped.</p>

<p>Preliminary Procedure</p>	
<p>1. Remove the front rear compartment trim. Refer to Rear Compartment Front Trim Panel Replacement.</p>	
<p>2. Program the communication interface module (OnStar®) after replacement. Refer to</p>

1	Navigation Receiver Nut (Qty: 2) Caution: Refer to Fastener Caution in the Preface section. Tighten 3.5 N·m (31 lb in)
2	Navigation Receiver Assembly
