Communication Interface Module Replacement

Removal Procedure

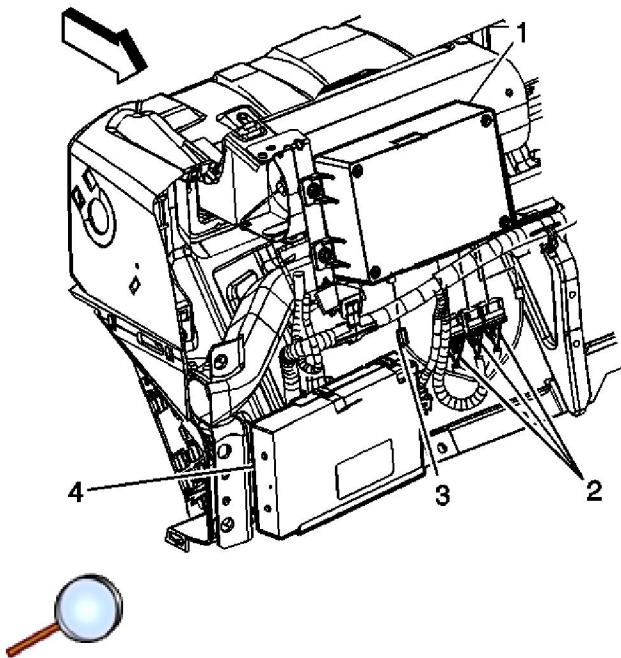
1. Remove the instrument panel (I/P) upper trim panel. Refer to [Instrument Panel Upper Trim Panel Replacement](#).
2. Fully open the I/P storage compartment.
3. Disconnect the electrical connectors (2) from the vehicle communication interface module (VCIM) (1).
4. Disconnect the coaxial cable (3) from the VCIM.
