Communication Interface Module Replacement

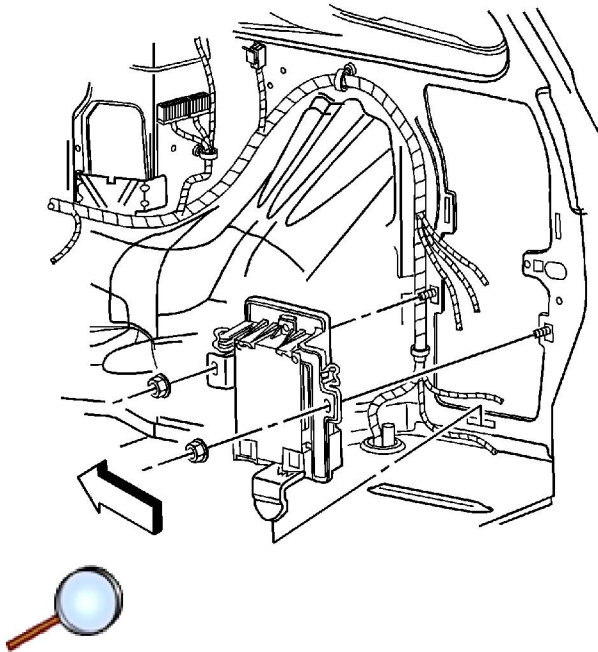
Important: The vehicle communication interface module (VCIM) has a specific set of unique numbers that tie the module to each vehicle. These numbers, the 10-digit station identification and the 11-digit electronic serial number, are used by the National Cellular Network and OnStar® to identify the specific vehicle. Because these numbers are tied to the vehicle identification number of the vehicle, you must never exchange these parts with those of another vehicle.

1. Remove the right rear body side trim. Refer to [Body Side Rear Trim Panel Replacement](#) .
2. Remove the nuts securing the OnStar® module to the vehicle body.

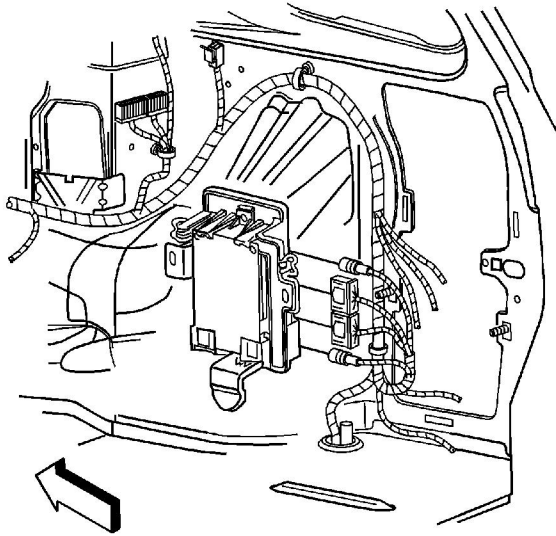
3. Disconnect all the electrical connectors from the module.
4. Remove the module from the vehicle.

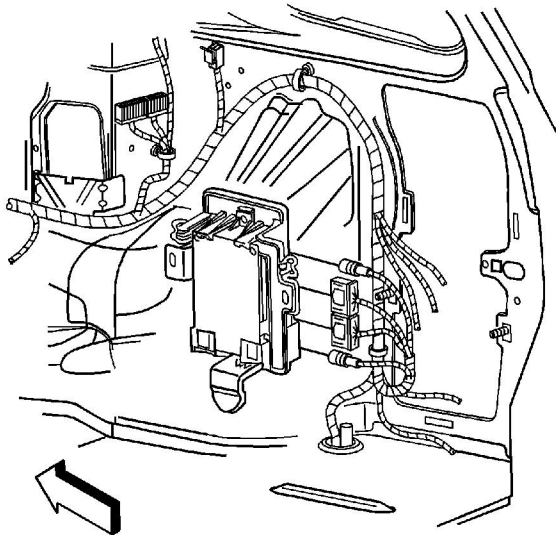
1. When replacing the VCIM, record the 11-digit electronic serial number (ESN) and the 10-digit station identification (STID) number from the label on the new VCIM.
2. Reconnect the electrical connectors the module.
