# Communication Interface Module Replacement

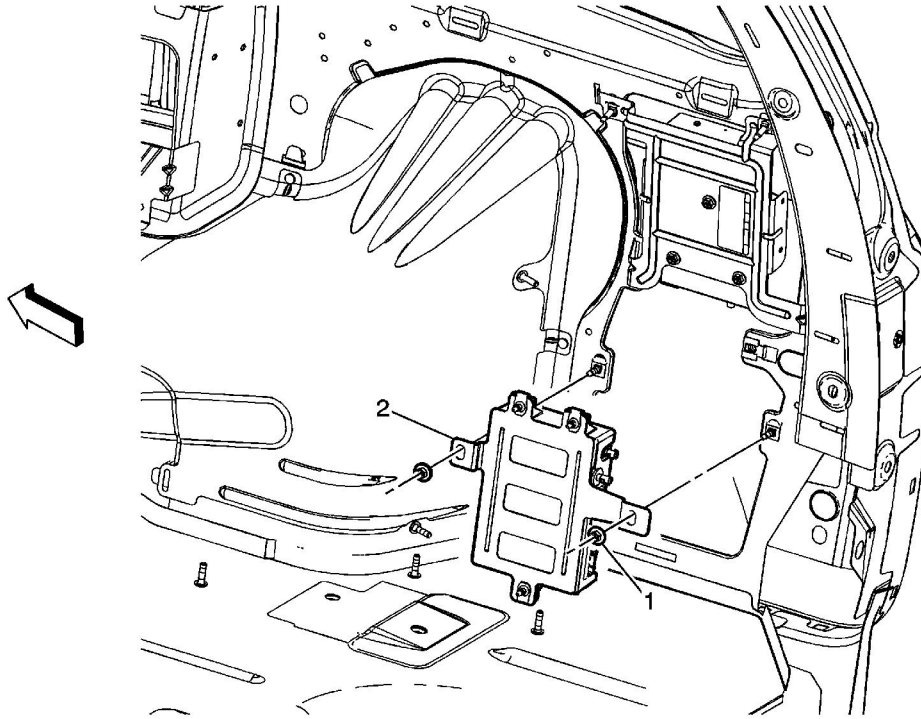
Callout	Component Name
<b>Preliminary Procedure</b>	
Remove the outer radio rear speaker. Refer to <a href="#">Radio Rear Speaker Replacement</a> .	
1	Communication Interface Module Nut (Qty: 2) <b>Caution:</b> Refer to <a href="#">Fastener Caution</a> in the Preface section.  <b>Tighten</b> 9 N·m (80 lb in)
	Communication Interface Module  <b>Procedure:</b> <ol style="list-style-type: none"> <li>1. Disconnect the electrical connectors.</li> <li>2. Reprogram the communication interface module if replaced. Refer to <a href="#">Control Module References</a>.</li> <li>3. If replacing the communication interface module be sure to transfer Bluetooth Antenna, if equipped.</li> <li>4. When replacing the VCIM, record the 11-digit electronic serial number (ESN)</li> </ol>
