2005 Cadillac STS | STS (VIN D) Service Manual | Accessories | Cellular Communication | Repair Instructions |

Communication Interface Module Replacement

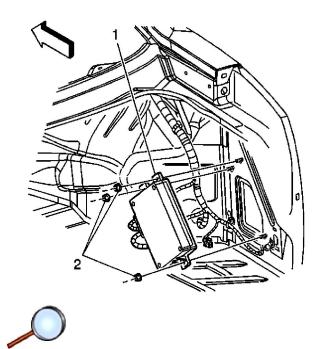
- 1. Remove the right rear compartment trim. Refer to Rear Compartment Trim Panel Replacement .
- 2. Remove the nuts (2) securing the OnStar® module (1) to the vehicle body.

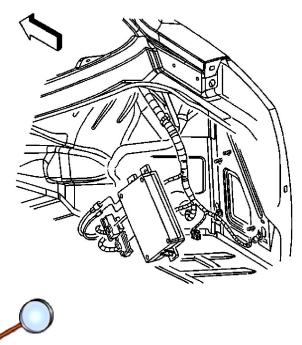
- 3. Disconnect all the electrical connectors from the module.
- 4. Remove the module from the vehicle.

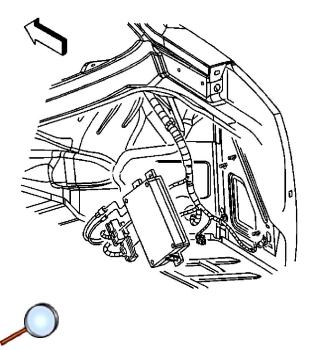
- 1. When replacing the VCIM, record the 11-digit electronic serial number (ESN) and the 10-digit station identification (STID) number from the label on the new VCIM.
- 2. Reconnect the electrical connectors the module.

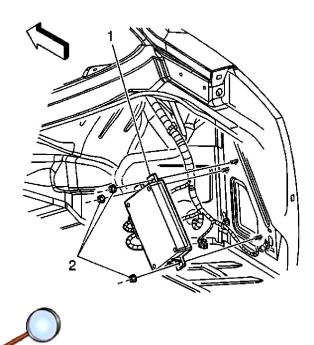
3. Install the module onto the vehicle.

Tighten the nuts to 9 N·m (80 lb in).
