Communication Interface Module Replacement

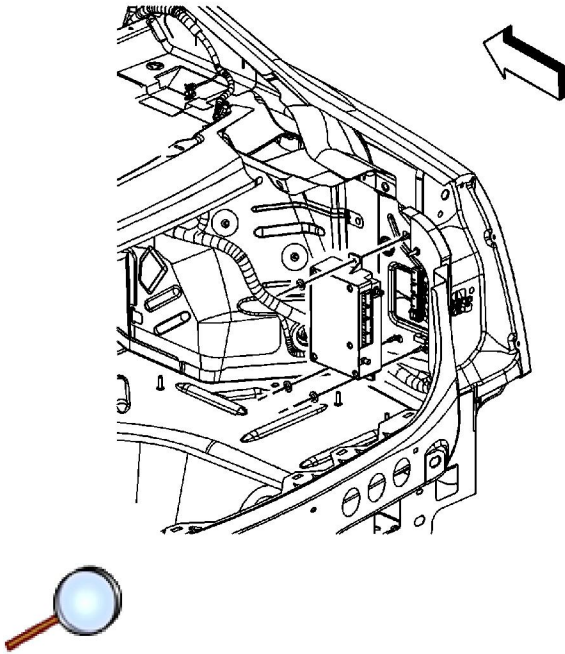
Important: The vehicle communication interface module (VCIM) has a specific set of unique numbers that tie the module to each vehicle. These numbers, the 10-digit station identification (STID) and the 11-digit electronic serial number (ESN), are used by the National Cellular Network and OnStar® to identify the specific vehicle. Because these numbers are tied to the vehicle identification number of the vehicle, you must never exchange these parts with those of another vehicle.

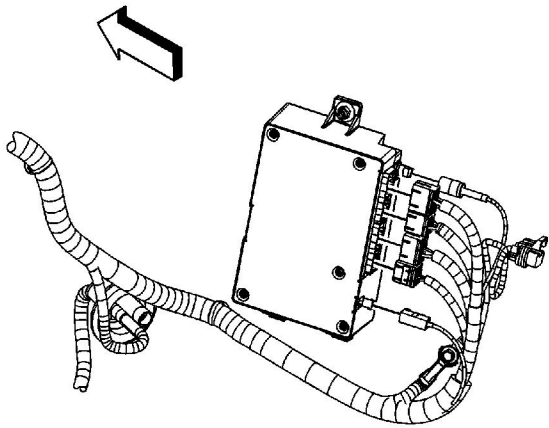
1. Remove the right rear compartment trim. Refer to [Rear Compartment Trim Panel Replacement](#) .
2. Remove the nuts securing the OnStar® module to the vehicle body.

3. Disconnect all the electrical connectors from the module.
4. Remove the module from the vehicle.

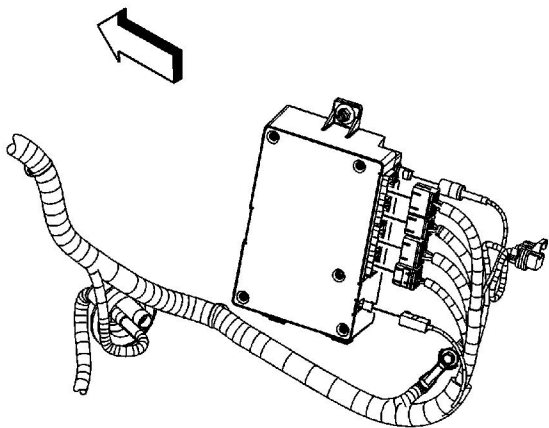
1. When replacing the VCIM, record the 11-digit ESN and the 10-digit STID number from the label on the new VCIM.
2. Reconnect the electrical connectors the module.

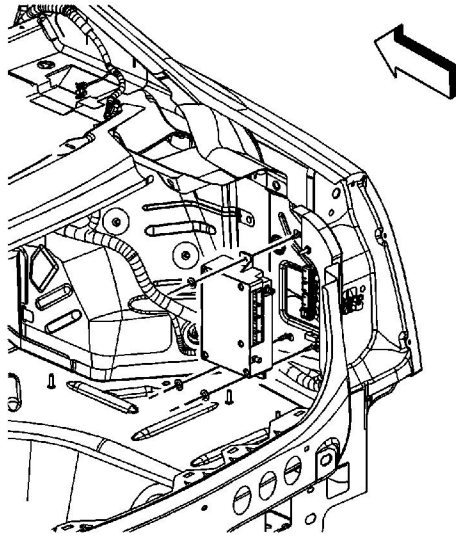
3. Install the module onto the vehicle.

Tighten the nuts to 9 N·m (80 lb in).
