2004 Cadillac XLR | XLR (VIN Y) Service Manual | Vehicle Control Systems | Document ID: 1326522

Communication Interface Module Replacement

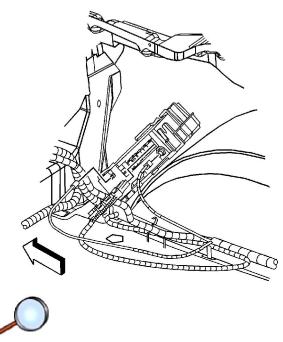
plastic housing.

5. Align the module to the vehicle antenna module bracket.

6. Install the communication interface module screws.

Tighten the screws to 2 N·m (18 lb in).
