2007 Cadillac XLRXLR (VIN Y) Service ManualDriver Information and EntertainmentCellular, Entertainment, and NavigationRepair InstructionsDocument ID: 1713650

Communication Interface Module Replacement

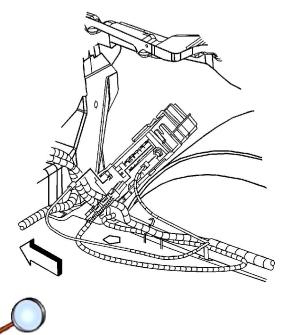
- 2. Connect the navigation antenna coaxial cable to the module.
- 3. Connect the electrical connectors.
- 4. Connect the mobile telephone-rantemnarsable to the anorgale reserves hing inward on the square

plastic housing.

5. Align the module to the vehicle antenna module bracket.
