Communication Interface Module Replacement

Removal Procedure

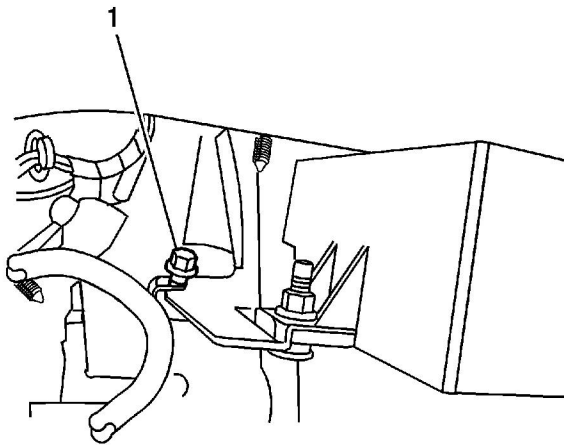
8. Install the VCIM screw (1) to the I/P.

Tighten the screws to 2 N·m (18 lb in).

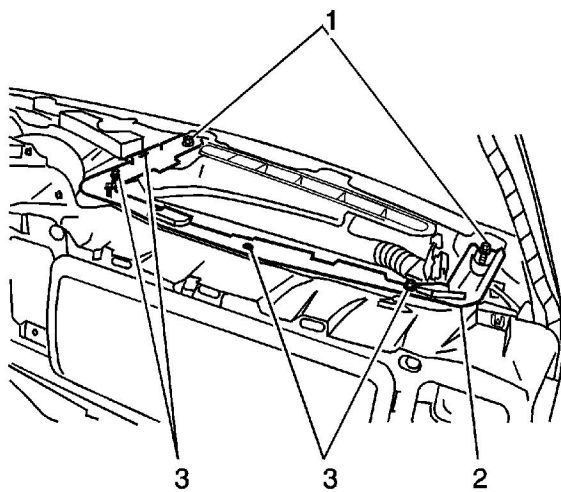
9. Install the passenger side upper I/P bracket (2).
10. Install the I/P upper bracket screws (3).

Tighten the screws (3) to 2 N·m (18 lb in).

11. Install the I/P upper bracket screws (1).

Tighten the screws (1) to 50 N·m (37 lb ft).
