Communication Interface Module Replacement

Removal Procedure

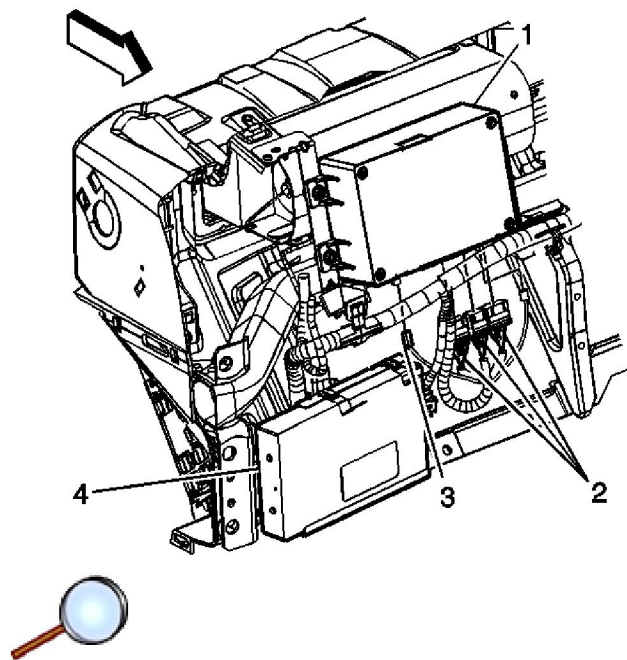
1. Remove the instrument panel (I/P) upper trim panel. Refer to [Instrument Panel Upper Trim Panel Replacement](#).
2. Fully open the I/P storage compartment.
3. Disconnect the electrical connectors (2) from the VCIM (1).
4. Disconnect the coaxial cable (3) from the VCIM.

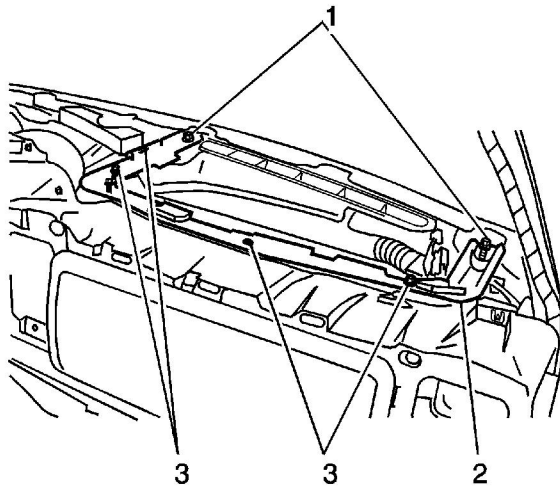
5. Remove the screws (1, 3) from the passenger side upper I/P support (2).
6. Remove the passenger side upper I/P support (2).

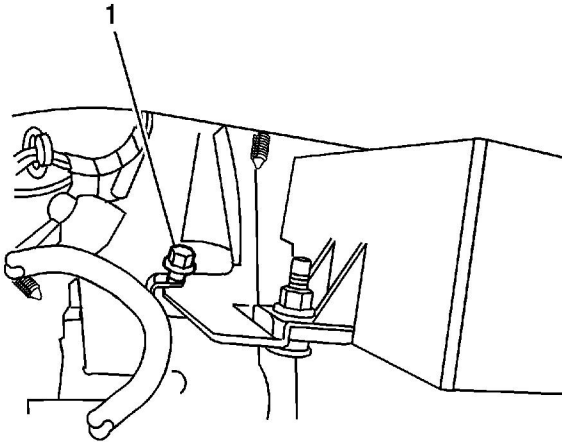
8. Install the VCIM screw (1) to the I/P.

Tighten the screws to 2 N·m (18 lb in).

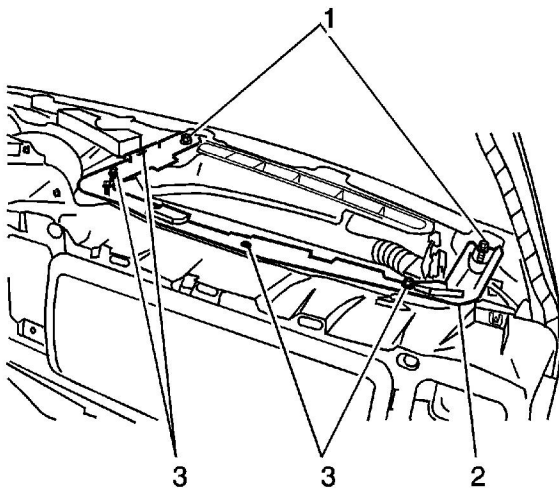
9. Install the passenger side upper I/P bracket (2).
10. Install the I/P upper bracket screws (3).

Tighten the screws (3) to 2 N·m (18 lb in).

11. Install the I/P upper bracket screws (1).

Tighten the screws (1) to 50 N·m (37 lb ft).
