Communication Interface Module Replacement

Removal Procedure

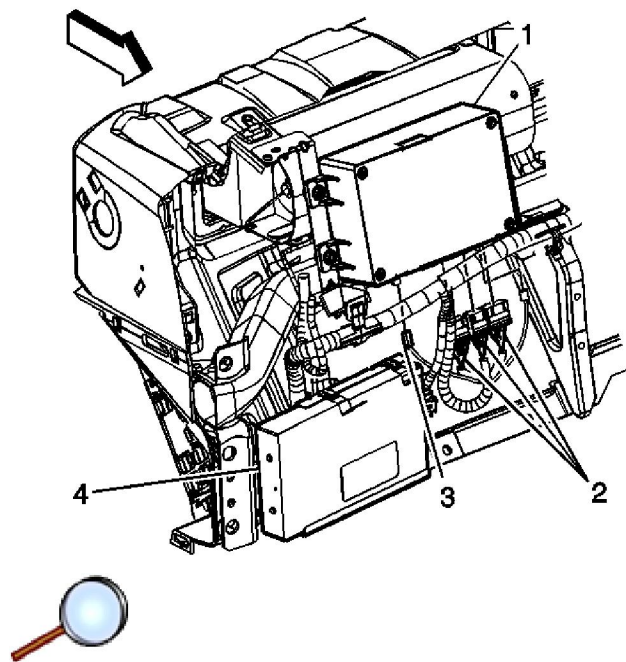
1. Remove the instrument panel (I/P) upper trim panel. Refer to [Instrument Panel Upper Trim Panel Replacement](#).
2. Fully open the I/P storage compartment.
3. Disconnect the electrical connectors (2) from the VCIM (1).
4. Disconnect the coaxial cable (3) from the VCIM.

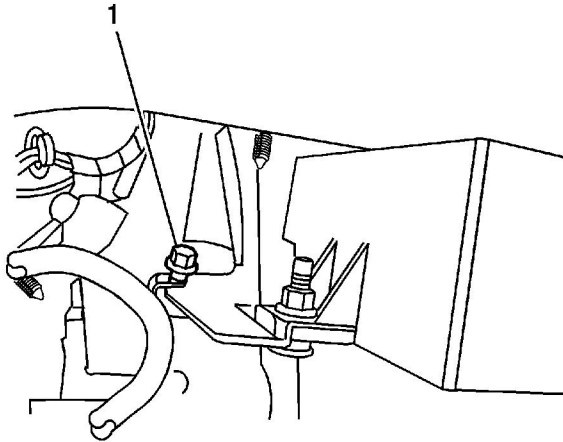
8. Install the VCIM screw (1) to the I/P.

Tighten the screws to 2 N·m (18 lb in).
