## Communication Interface Module Replacement

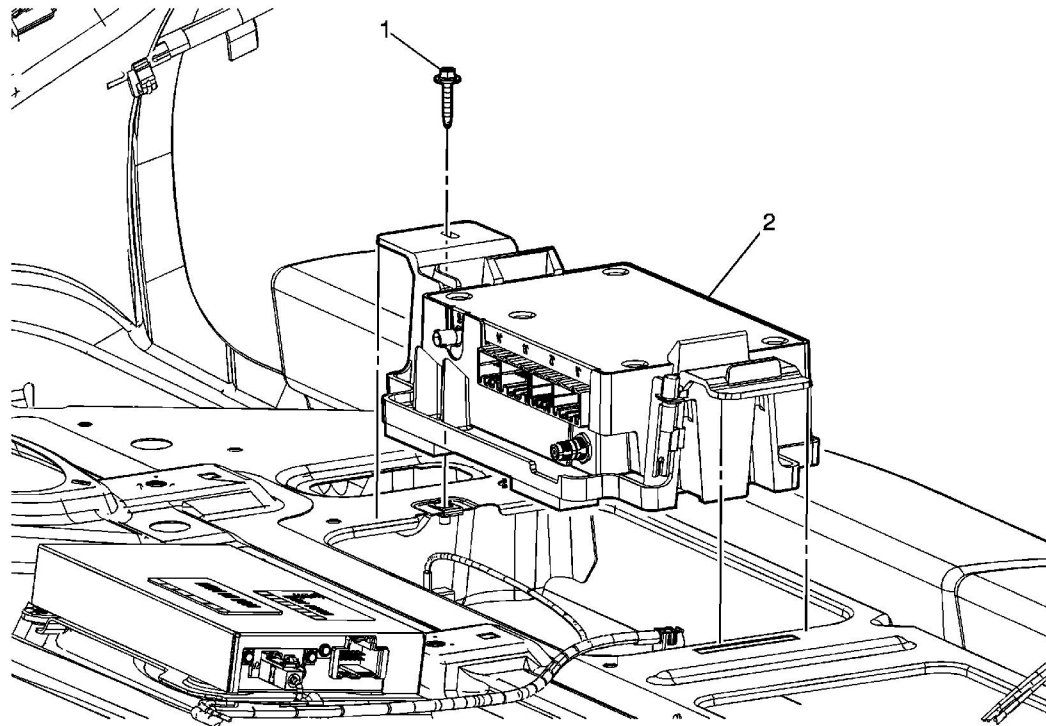
Callout	Component Name
<p><b>Preliminary Procedures</b></p> <ol style="list-style-type: none"> <li>1. Remove the rear shelf trim. Refer to <a href="#">Rear Window Shelf Trim Panel Replacement</a>.</li> <li>2. The vehicle communication interface module (VCIM) has a specific set of unique numbers that tie the module to each vehicle. These numbers, the 10-digit station identification (STID) and the 11-digit electronic serial number (ESN), are used by the National Cellular Network and OnStar® to identify the specific vehicle. Because these numbers are tied to the vehicle identification number of the vehicle, you must never exchange these parts with those of another vehicle.</li> </ol>	
<p>1</p>	<p>Vehicle Communication Module Bolt</p> <p><b>Caution:</b> Refer to <a href="#">Fastener Caution</a> in the Preface section.</p> <p><b>Tip</b> When replacing the VCIM, record the 11-digit ESN and 10-digit STID number from the label on the new VCIM.</p> <p><b>Tighten</b> 9 N·m (80 lb in)</p>

<p>Vehicle Communication Module Assembly</p>
