2008 Chevrolet Colorado Pickup - 2WD | Canyon, Colorado, I-290, I-370 (VIN S/T) Service Manual | Driver Information and Entertainment | Cellular, Entertainment, and Navigation | Repair Instructions |

Communication Interface Module Replacement

Removal Procedure

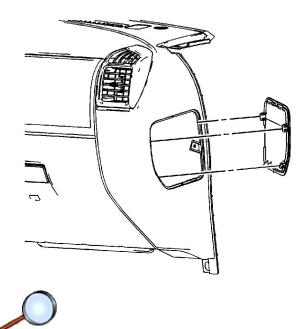
2. Remove the service panel located on the right side of the instrument panel (I/P).

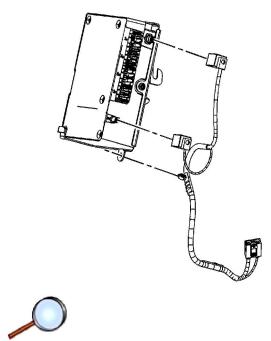
3. Disconnect the VCIM electrical connectors as necessary.
