Communication Interface Module Replacement

Removal Procedure

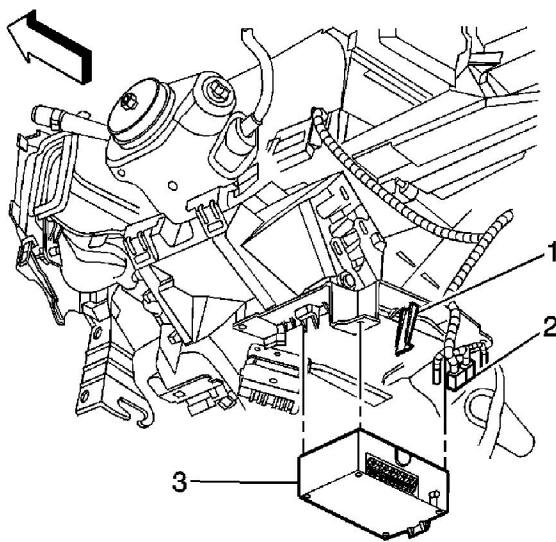
1. Remove the drivers knee bolster. Refer to [Driver Knee Bolster Replacement](#) in Instrument Panel, Gages and Console.
2. Disconnect the electrical connectors and the coaxial cable (2) from the module.
3. Release the communication interface module retaining tab (1).
4. Remove the communication interface module (3) from the module bracket.

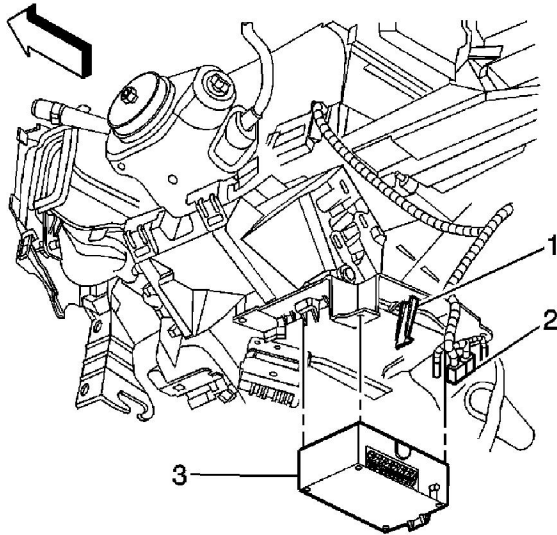
1. When replacing a VCIM, record the 11-digit electronic serial number (ESN) and the 10-digit station identification (STID) number from the label on the new VCIM.
2. Slide the communication interface module (3) into the bracket.
3. Push in on the module (3) at the retaining tab (2) until an audible click is heard indicating the module is secured to the bracket.
4. Connect the electrical connectors and the coaxial cable (2) to the communication interface module (3).
