> 2007 Chevrolet HHR | HHR (VIN A) Service Manual | Driver Information and Entertainment | Cellular, Entertainment, and Navigation | Repair Instructions | Document ID: 1737752

Communication Interface Module Replacement

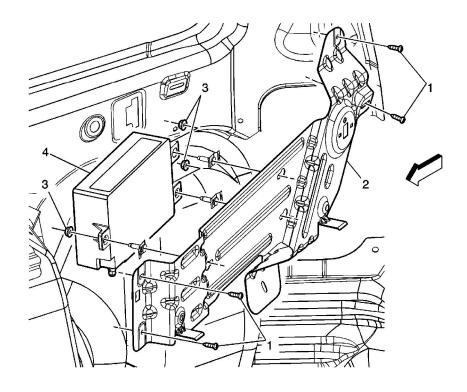
Callout	Component Name
Preliminary Procedures	
2. R€	emove the rear seat. Refer to <u>Rear Seat Replacement</u> . Emove the right rear quarter lower trim panel. Refer to <u>Quarter Lower Rear Trim</u> Inel Replacement.
	Quarter Inner Trim Panel Bracket Screw (Qty: 4)
1	Notice: Refer to <u>Fastener Notice</u> in the Preface section.
	Tighten 10 N·m (89 lb in)
2	Quarter Inner Trim Panel Bracket
	Communication Interface Module Nut (Qty: 3)
3	Tighten 10 N·m (89 lb in)
	Communication Interface Module
	Procedure © 2012 General Motors Corporation. All rights reserved.

1. Disconnect the electrical connector.

2. Reprogram the communication interface module after installation. Refer to $\underline{\text{Control Module References}} \ .$
