Communication Interface Module Replacement

Removal Procedure

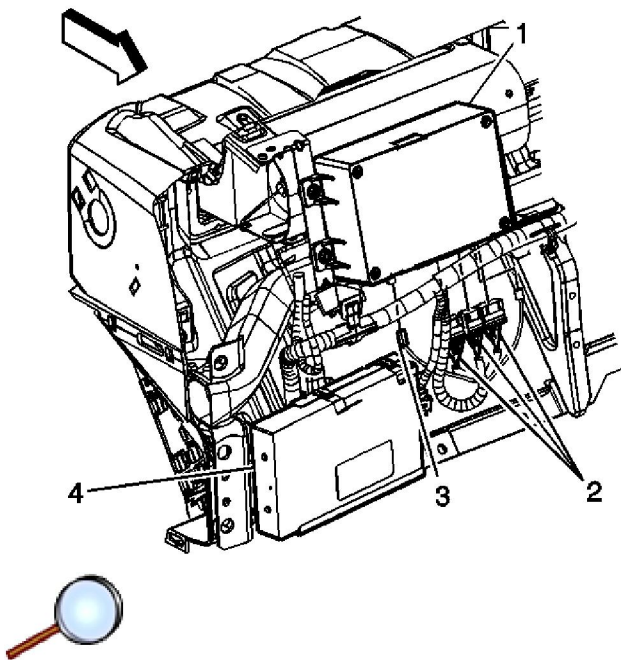
1. Remove the instrument panel (I/P) upper trim panel. Refer to [Instrument Panel Upper Trim Panel Replacement](#).
2. Fully open the I/P storage compartment.
3. Disconnect the electrical connectors (2) from the vehicle communication interface module (VCIM) (1).
4. Disconnect the coaxial cable (3) from the VCIM.

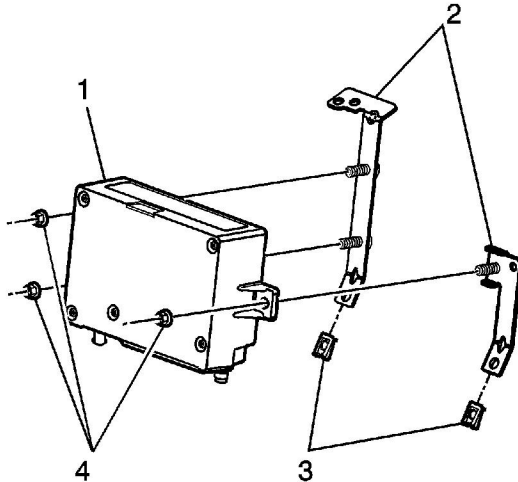
1. If replacing the VCIM, record the 10-digit STID number, and the 11-digit ESN number from the labels on the new module.
2. Ensure the nuts (3) are installed on the module mounting brackets (3).
3. Install the mounting brackets (2) to the VCIM (1).

4. Install the nuts (4).

Tighten the nuts to 2 N·m (18 lb in).

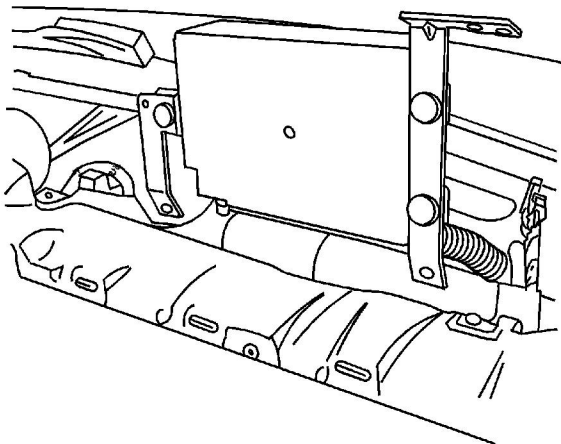
6. Install the VCIM and bracket assembly to the I/P.
7. Install the push in retainer.
