Communication Interface Module Replacement

Removal Procedure

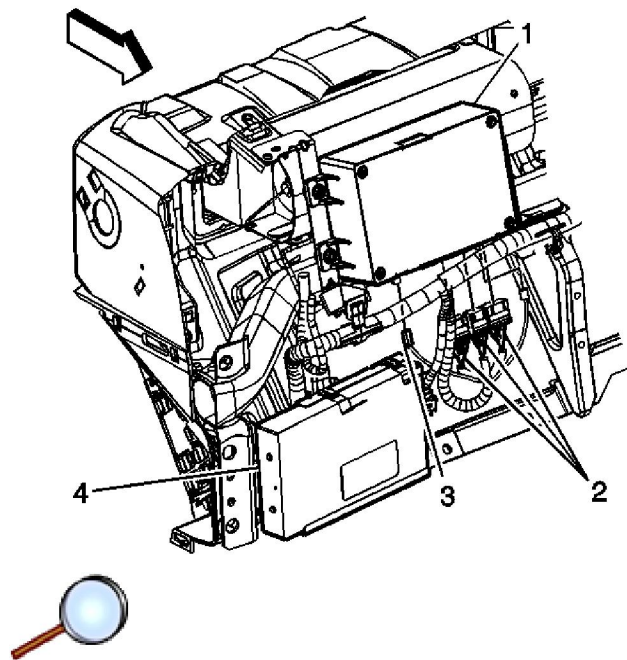
1. Remove the instrument panel (I/P) upper trim panel. Refer to [Instrument Panel Upper Trim Panel Replacement](#).
2. Fully open the I/P storage compartment.
3. Disconnect the electrical connectors (2) from the VCIM (1).
4. Disconnect the coaxial cable (3) from the VCIM.

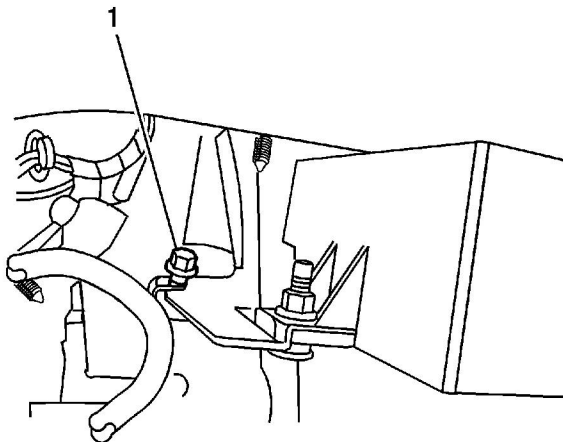
7. Remove the screw (1) retaining the VCIM bracket to the I/P.
8. Remove the retainer from the VCIM bracket.
9. Remove the nuts holding the mounting brackets to the VCIM.
10. If necessary, move the cross-car duct forward slightly in order to make room for the removal of the module.

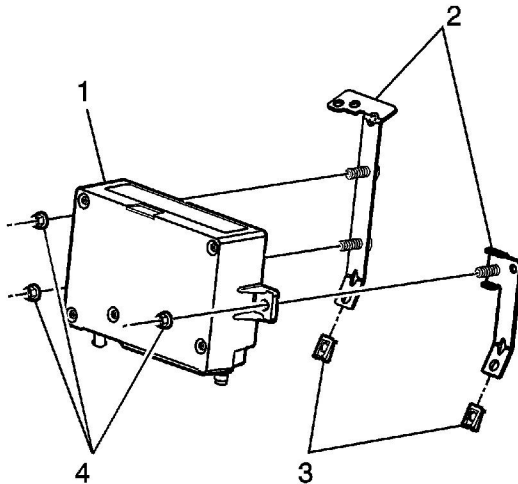
1. If replacing the VCIM, record the 10-digit STID number, and the 11-digit ESN number from the labels on the new module.
2. Ensure the nuts (3) are installed on the module mounting brackets (3).
3. Install the mounting brackets (2) to the VCIM (1).

4. Install the nuts (4).

Tighten the nuts to 2 N·m (18 lb in).
