Communication Interface Module Replacement

Removal Procedure

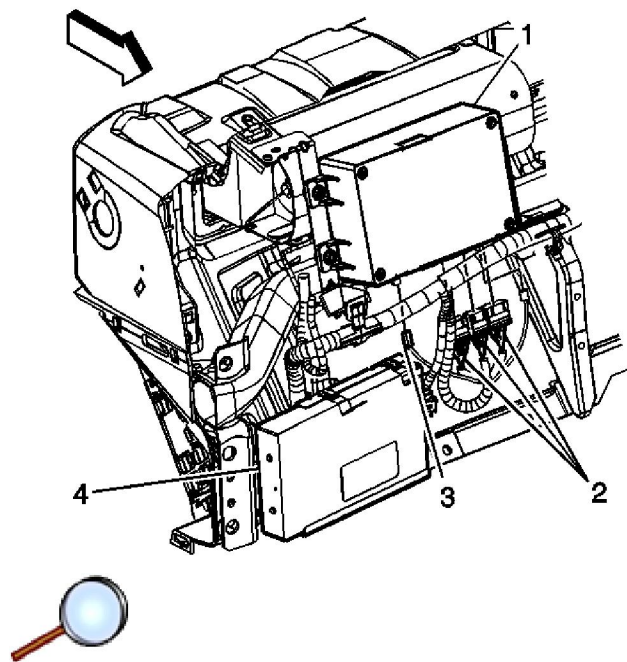
1. Remove the instrument panel (I/P) upper trim panel. Refer to [Instrument Panel Upper Trim Panel Replacement](#).
2. Fully open the I/P storage compartment.
3. Disconnect the electrical connectors (2) from the VCIM (1).
4. Disconnect the coaxial cable (3) from the VCIM.
