Communication Interface Module Replacement

Removal Procedure

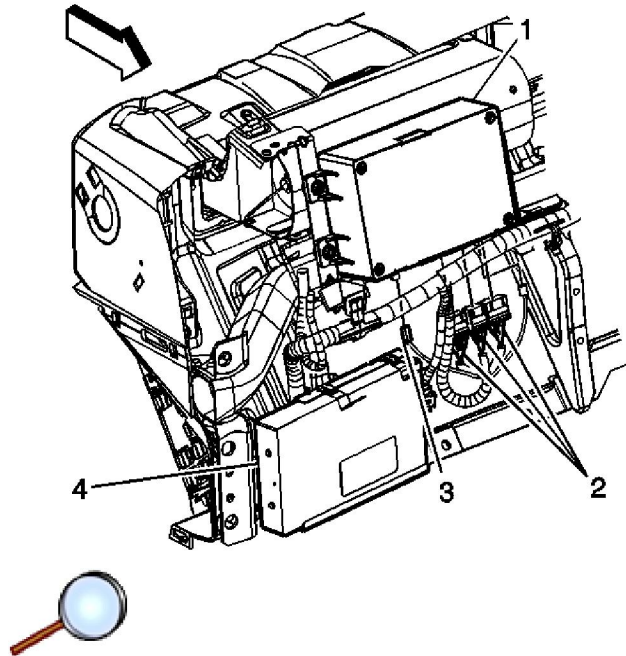
12. Connect the coaxial cable (3) to the VCIM.
13. Connect the electrical connectors (2) to the VCIM.
14. Install the I/P trim panel. Refer to [Instrument Panel Upper Trim Panel Replacement](#) .
