2007 GMC Truck Canyon Pickup - 2WD | Canyon, Colorado, I-290, I-370 (VIN S/T) Service Manual | Driver Information and Entertainment | Cellular, Entertainment, and Navigation | Repair Instructions | Document ID: 1719371

Communication Interface Module Replacement

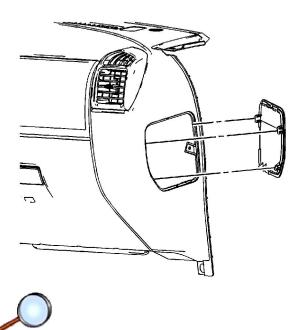
2. Remove the service panel located on the right side of the instrument panel (I/P).

4. Install the service panel.

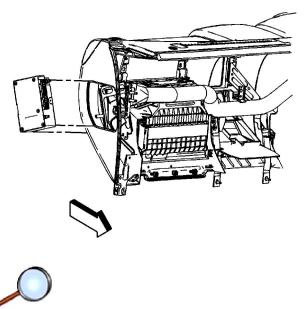
6. Remove the VCIM from the bracket.

7. Remove the VCIM from the vehicle.
