## Communication Interface Module Replacement

### Removal Procedure

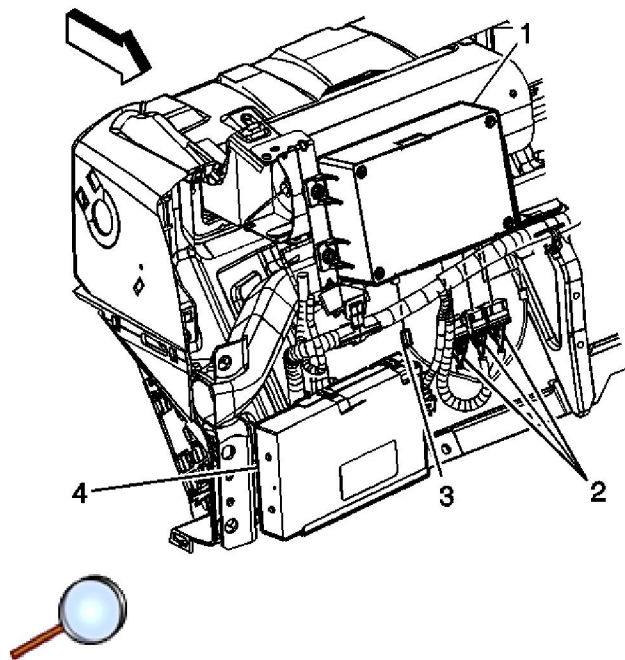
1. Remove the instrument panel (I/P) upper trim panel. Refer to [Instrument Panel Upper Trim Panel Replacement](#).
2. Fully open the I/P storage compartment.
3. Disconnect the electrical connectors (2) from the VCIM (1).
4. Disconnect the coaxial cable (3) from the VCIM.
