# Communication Interface Module Replacement

## Removal Procedure

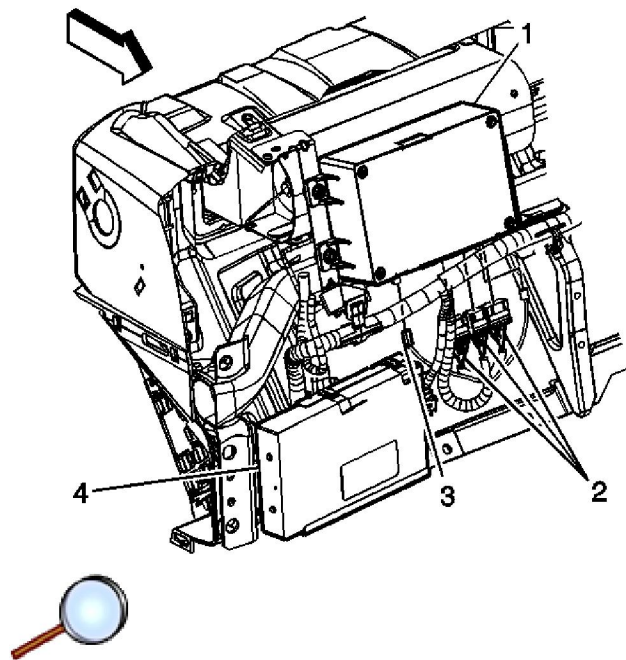
1. Remove the instrument panel (I/P) upper trim panel. Refer to [Instrument Panel Upper Trim Panel Replacement](#).
2. Fully open the I/P storage compartment.
3. Disconnect the electrical connectors (2) from the VCIM (1).
4. Disconnect the coaxial cable (3) from the VCIM.

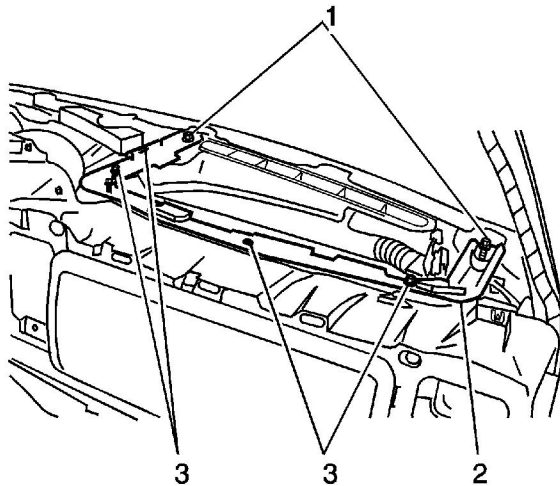
5. Remove the screws (1, 3) from the passenger side upper I/P support (2).
6. Remove the passenger side upper I/P support (2).

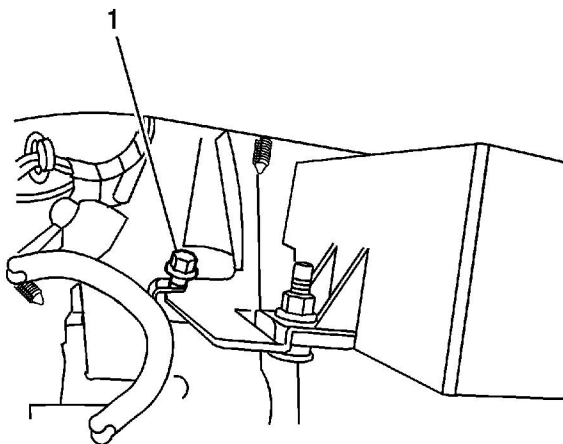
7. Remove the screw (1) retaining the VCIM bracket to the I/P.
8. Remove the retainer from the VCIM bracket.
9. Remove the nuts holding the mounting brackets to the VCIM.
10. If necessary, move the cross-car duct forward slightly in order to make room for the removal of the module.

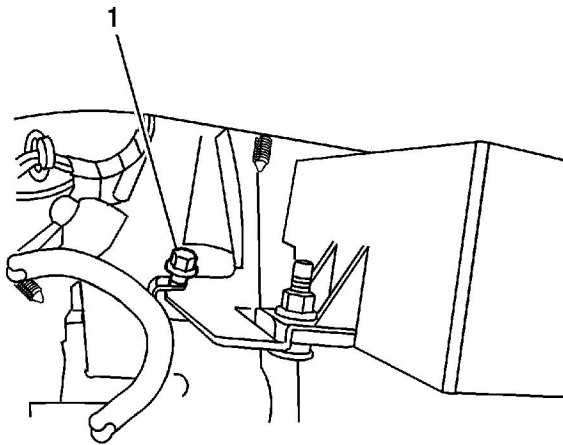
8. Install the VCIM screw (1) to the I/P.

Tighten the screws to 2 N·m (18 lb in).

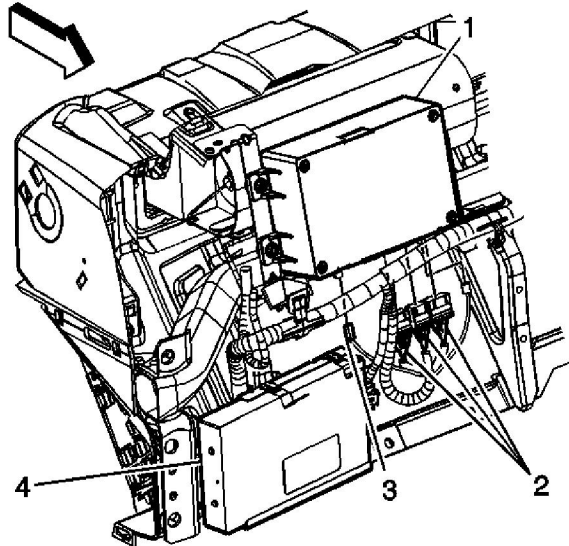
12. Connect the coaxial cable (3) to the VCIM.
13. Connect the electrical connectors (2) to the VCIM.
14. Install the I/P trim panel. Refer to [Instrument Panel Upper Trim Panel Replacement](#) .
