## Communication Interface Module Replacement

### Removal Procedure

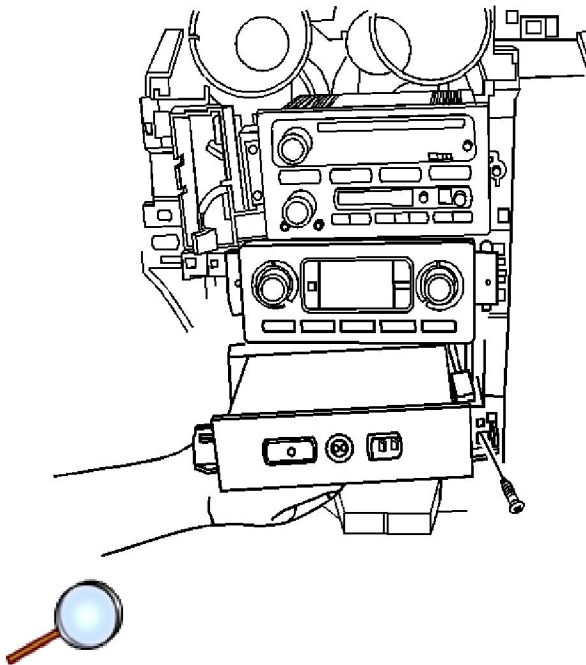
1. Remove the I/P center trim panel. Refer to [Instrument Panel Center Trim Panel Replacement](#) in Instrument Panel, Gages, and Console.

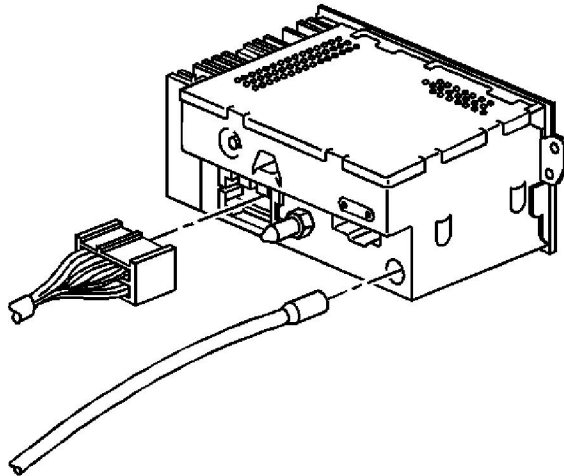
2. Remove the screws that hold the communication interface module to the I/P.

3. Disconnect the antenna and the electrical connections from the communication interface module.
4. Remove the communication interface module.

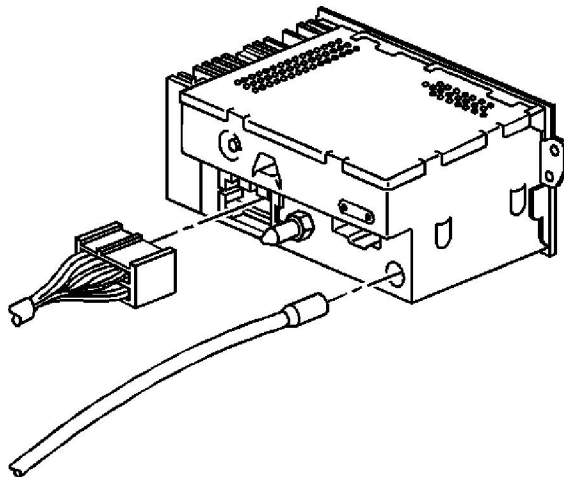
2. Connect the electrical and the antenna connections to the communication interface module.

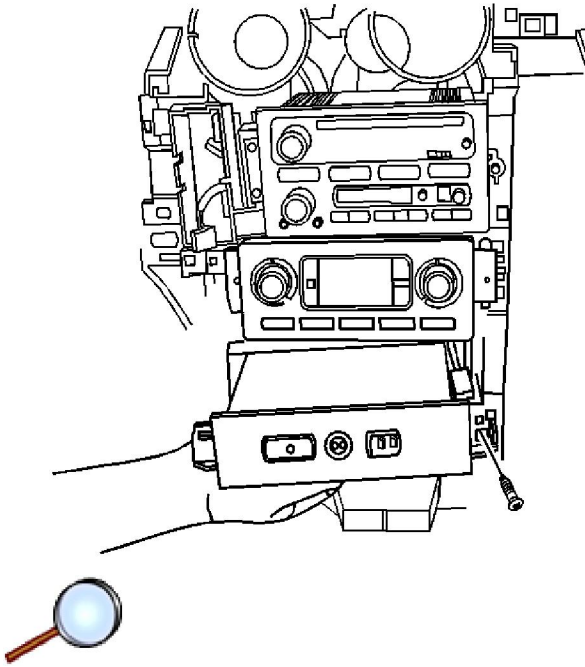
3. Install the communication interface module screws.

Tighten the screws to 2 N·m (18 lb in).
