## Communication Interface Module Replacement

### Removal Procedure

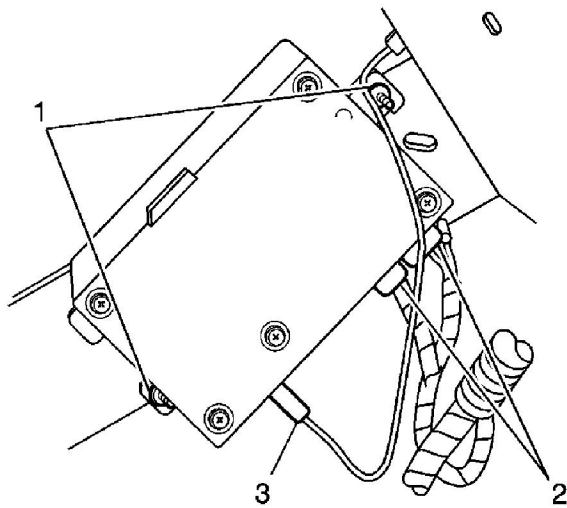
2. Disconnect the antenna (3) and electrical connections (2) from the vehicle communication interface module (VCIM).
3. Remove the bolts (1) securing the VCIM.
4. Remove the vehicle VCIM from the vehicle.
