Communication Interface Module Replacement

Removal Procedure

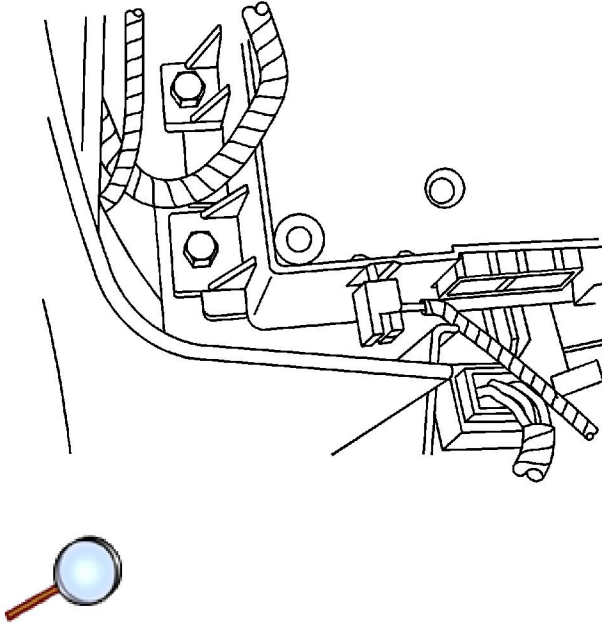
1. Remove the communication interface module screws.

The communication interface module is located forward of the floor console and under the instrument panel. There are two screws on the passenger side and one toward the driver side.
