Communication Interface Module Replacement

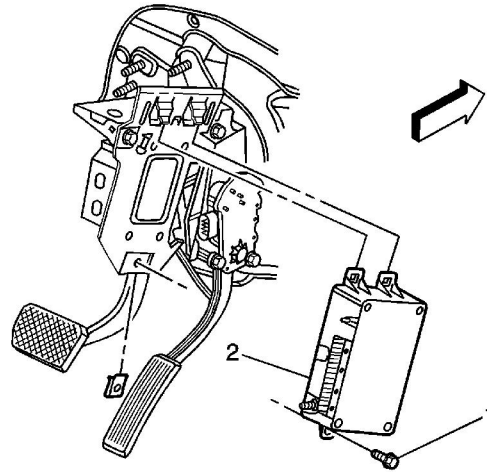
Callout	Component Name
<p>Notice: Refer to Fastener Notice in the Preface section.</p>	
<p>Important: The vehicle communication interface module (VICM) has a specific set of unique numbers that tie the module to each vehicle. These numbers, the 10-digit station identification and the 11-digit electronic serial number, are used by the National Cellular Network and OnStar® to identify the specific vehicle. Because these numbers are tied to the vehicle identification number of the vehicle, you must never exchange these parts with those of another vehicle.</p> <p><i>Fastener Tightening Specifications:</i> Refer to Fastener Tightening Specifications .</p> <p>Preliminary Procedure</p> <p>Remove the left instrument panel insulator. Refer to Instrument Panel Insulator Panel Replacement - Left Side.</p>	
<p>1</p>	<p>Communication Interface Module Bolt</p> <p>Tighten 10 N·m (89 lb in)</p>
<p>2</p>	<p>Communication Interface Module</p> <p>Tip</p> <ol style="list-style-type: none"> 1. Pull down to release the module from the bracket. 2. Disconnect the electrical connectors, the GPS antenna, and the cellular coax cable. 3. If replacing the module, record the 10-digit STID number, and the 11-digit ESN number from the labels on the new module.
