Communication Interface Module Replacement (Sedan)

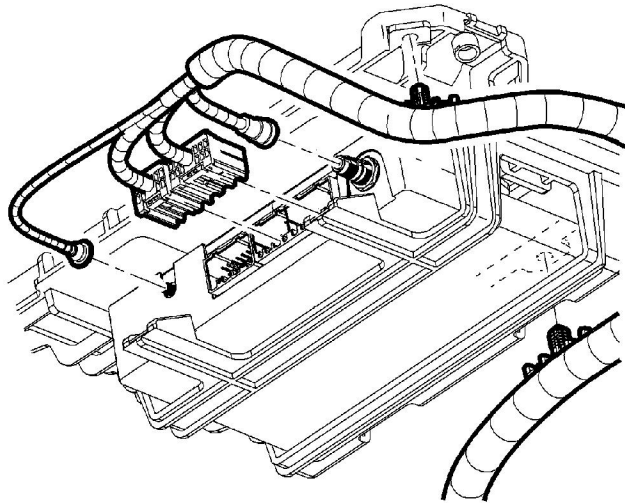
Installation Procedure

1. Slide the VCIM into the bracket.
2. Connect the GPS antenna coax cable.
3. Connect the wiring connectors.
4. Connect the cellular antenna coax cable
