2007 Saturn VUE - AWD | VUE (VIN Z) Service Manual | Driver Information and Entertainment | Cellular, Entertainment, and Navigation | Repair Instructions | Document ID: 1907505

Communication Interface Module Replacement <u>Removal Procedure</u>

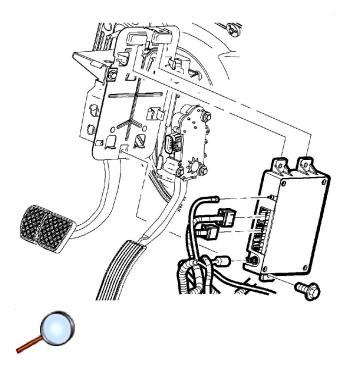
- 1. Remove the fastener located on the bottom of the OnStar® bracket.
- 2. Tilt the module inboard to the center of the vehicle and pull down the communication interface module (CIM)

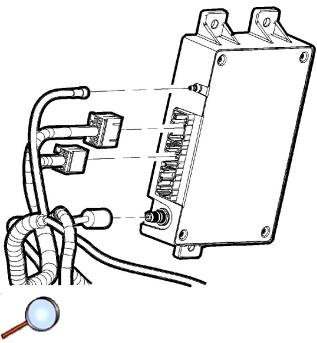
3. Disconnect the electrical connectors, the GPS antenna, and the cellular coax cable.

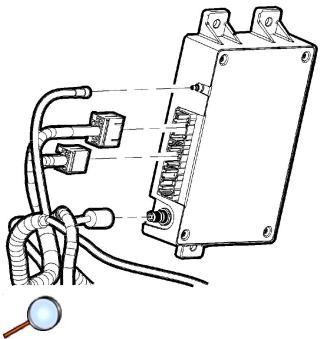
- 2. Connect the electrical connectors, the GPS antenna, and the cellular coax cable.
- 3. Tilt the CIM inboard and install the CIM.

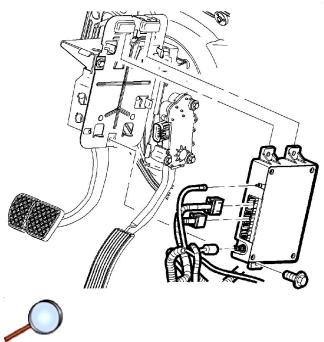
4. Install the CIM fastener.

Tighten the fastener to 10 N·m (89 lb in).
