2008 Cadillac CTS
 CTS (VIN D) Service Manual
 Driver Information and Entertainment

Cellular, Entertainment, and Navigation
 Repair Instructions
 Document ID: 1978224

## **Communication Interface Module Replacement**

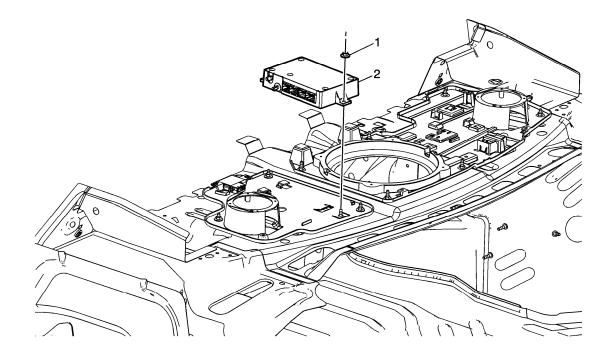
Callout	Component Name			
Preliminary Procedure				
Remove the rear window shelf trim panel. Refer to <u>Rear Window Panel Trim Replacement</u> .				
	Communication Interface Module Nut			
1	Notice: Refer to Fastener Notice in the Preface section.			
	<b>Tighten</b> 9 N·m (80 lb in)			
	Communication Interface Module			
2	Procedure			
	Disconnect the electrical connections.

If replacing the communication interface module be sure to transfer Bluetooth Antenna, if equipped.
	For programming and set up, refer to Control Module References
