2009 HUMMER H2 | H2 (VIN N) Service Manual | Driver Information and Entertainment |
Cellular, Entertainment, and Navigation | Repair Instructions | Document ID: 1937691

Communication Interface Module Replacement

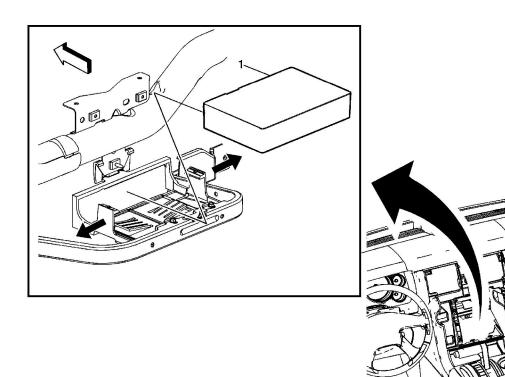
Communication Interface with Mobile Telephone Transceiver Module

- 1. Push outward on the two tabs to release the communication interface module from the bracket.
- 2. Disconnect the electrical connectors.
- 3. Reprogram the communication interface module after replacement. Refer to Control Module References.
- 4. When replacing the communication interface module be sure to transfer Bluetooth Antenna, if equipped.
